Carrying Capacity Study of Silver Glen Spring and Run

DEP Contract Number SL 982

Final Report

Submitted to the Florida Department of Environmental Protection
By Pandion Systems, Inc.

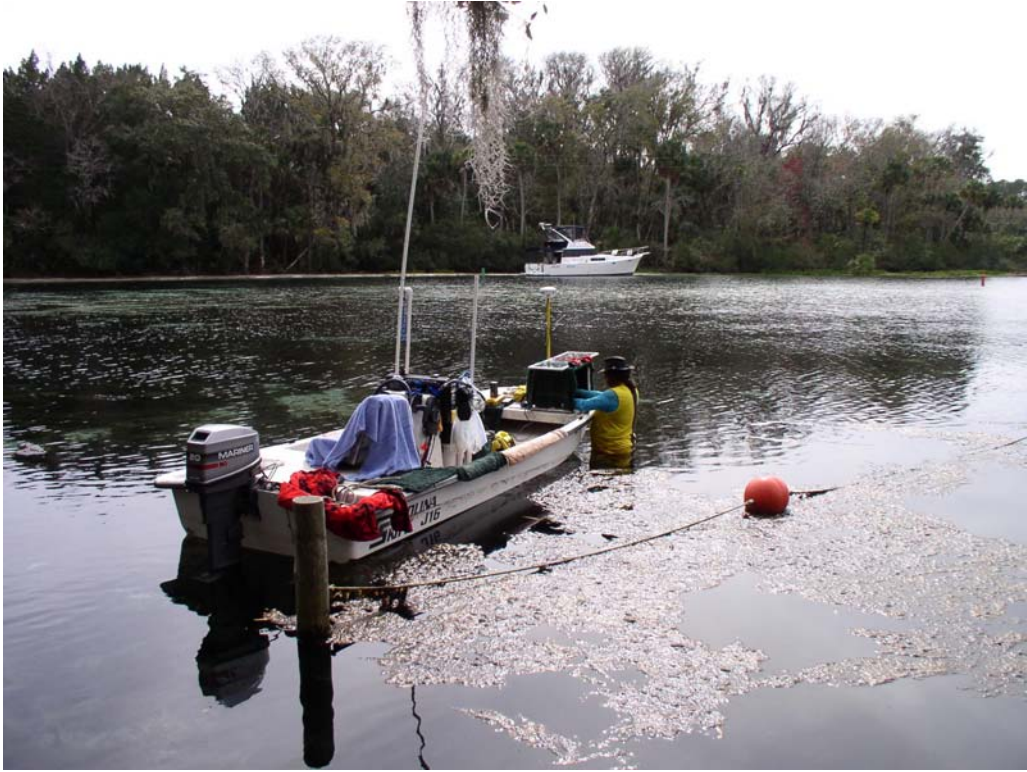
Mapping the vegetation at the spring

The field component of the study occurred during January-May of 2003. During that time, the submerged aquatic vegetation (SAV) communities were mapped using GIS technology for the entire length of the run. Information on species composition, percent cover, relative health/condition, substrate type, and approximate depth were collected for the vegetation. In addition, recreation use patterns and impacts from boaters and swimmers/waders were also documented and mapped. The impacts observed included propeller scars, anchor pits, grass chopping and trampling. Exclusion cages and surface buoy quadrats were also installed to study regrowth of the SAV but with limited success because of damage and vandalism.

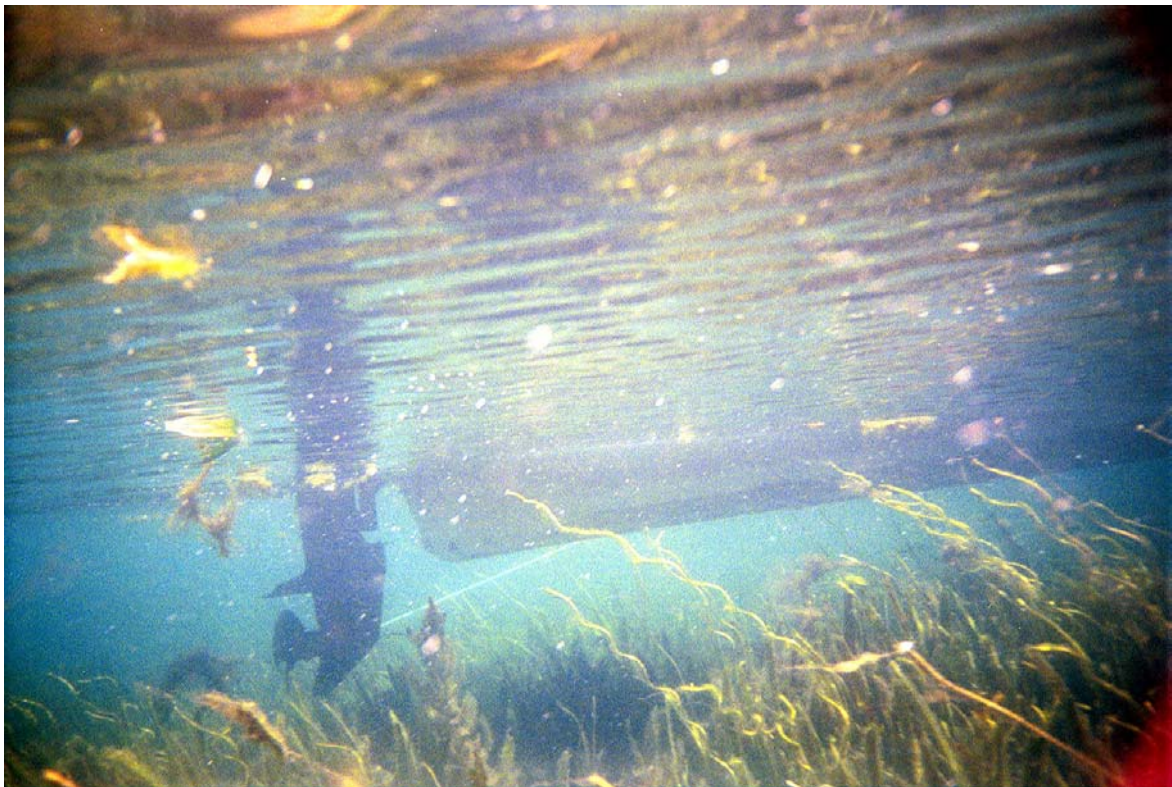
Flowering eelgrass and boat propeller

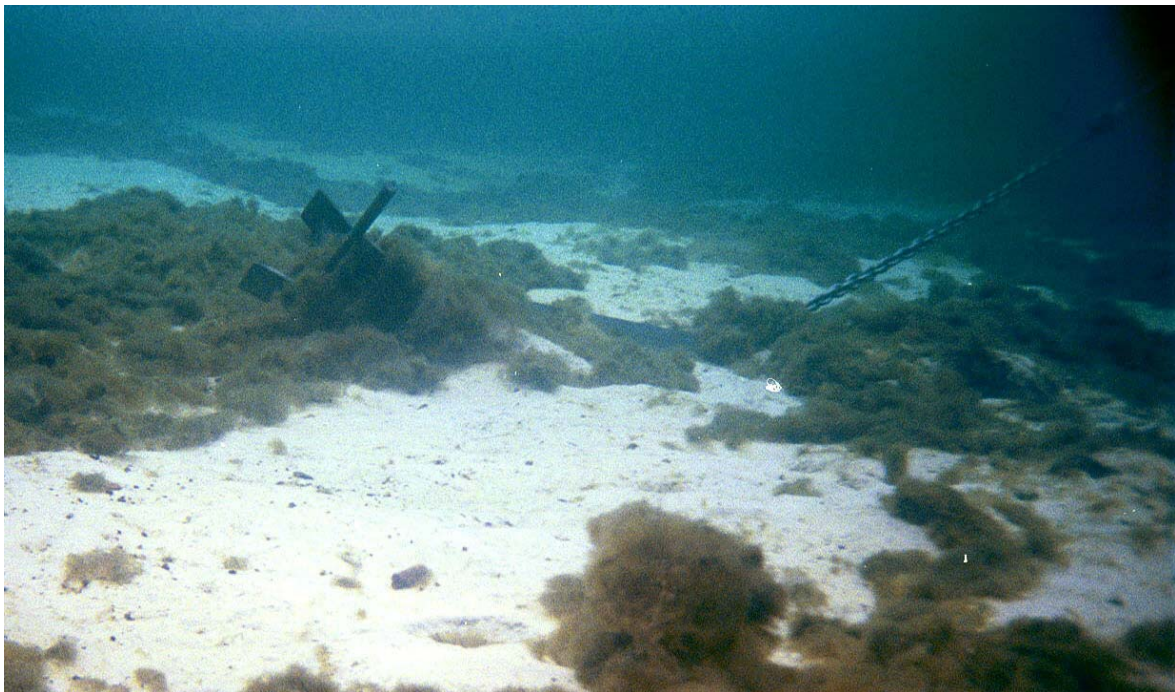
Anchor on substrate

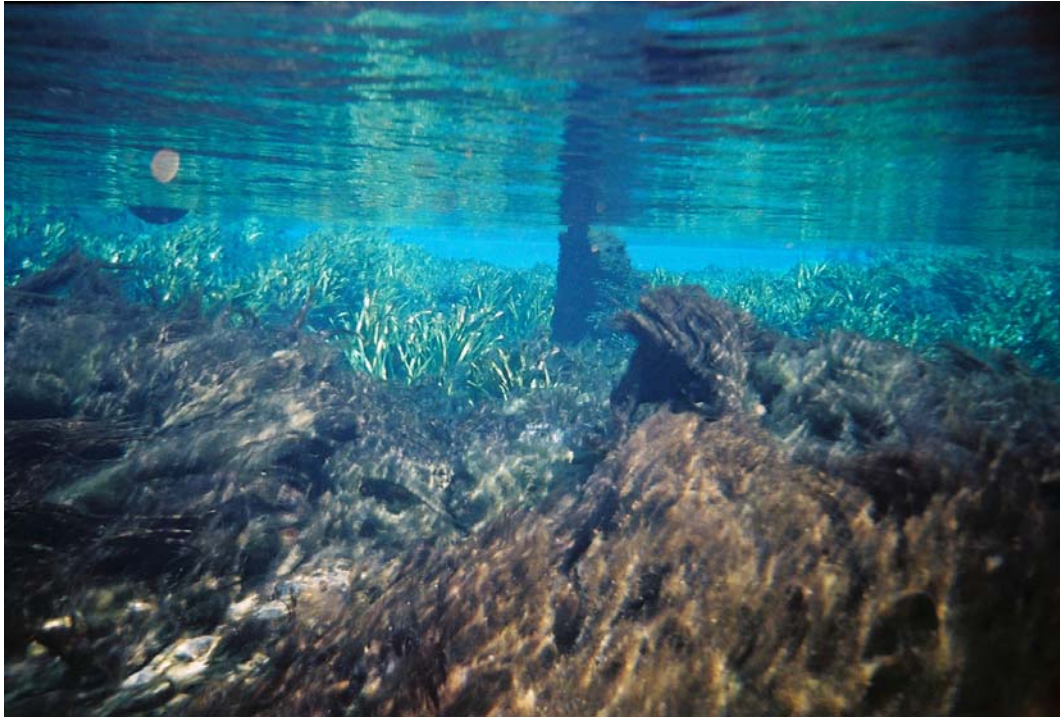
Algae mat near eelgrass
